From Tufte, Edward. *Visual Explanations: Images and Quantities, Evidence and Narrative*. Cheshire, CT: Graphics P, 1997.

The Decision to Launch the Space Shuttle Challenger

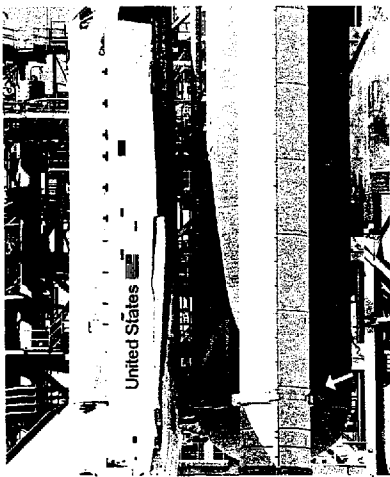
Less than 1 second after ignition, a puff of smoke appeared at the aft joint of the right booster, indicating that the O-rings burned through and failed to seal. At this point, all was lost.

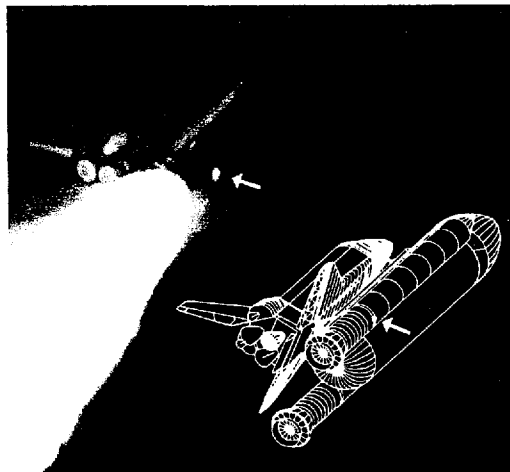
On the launch pad, the leak lasted only about 2 seconds and then apparently was plugged by putty and insulation as the shuttle rose, flying through rather strong cross-winds. Then 58.788 seconds after ignition, when the Challenger was 6 miles up, a flicker of flame emerged from the leaky joint. Within seconds, the flame grew and engulfed the fuel tank (containing liquid hydrogen and liquid oxygen). That tank ruptured and exploded, destroying the shuttle.

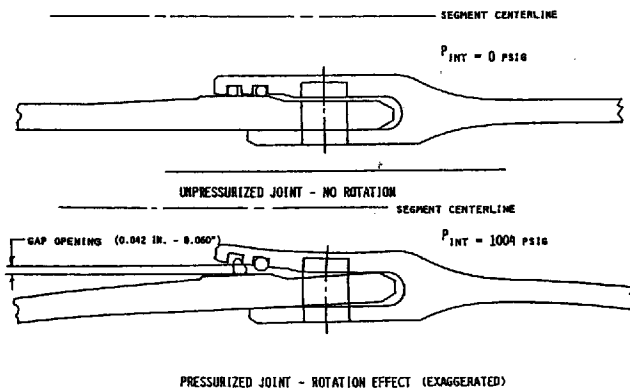
PRIMARY CONCERNS - CONT

The next chart (below left) describes how erosion in the primary O-ring interacts with its back-up, the secondary O-ring. Then two drawings (below right) make an effective visual comparison to show how rotation of the field joint degrades the O-ring seal. This vital effect, however, is not linked to the potential cause; indeed, neither chart appraises the phenomena described in relation to temperature.
