From Tufte, Edward. *Visual Explanations: Images and Quantities, Evidence and Narrative*. Cheshire, CT: Graphics P, 1997.

The Decision to Launch the Space Shuttle Challenger

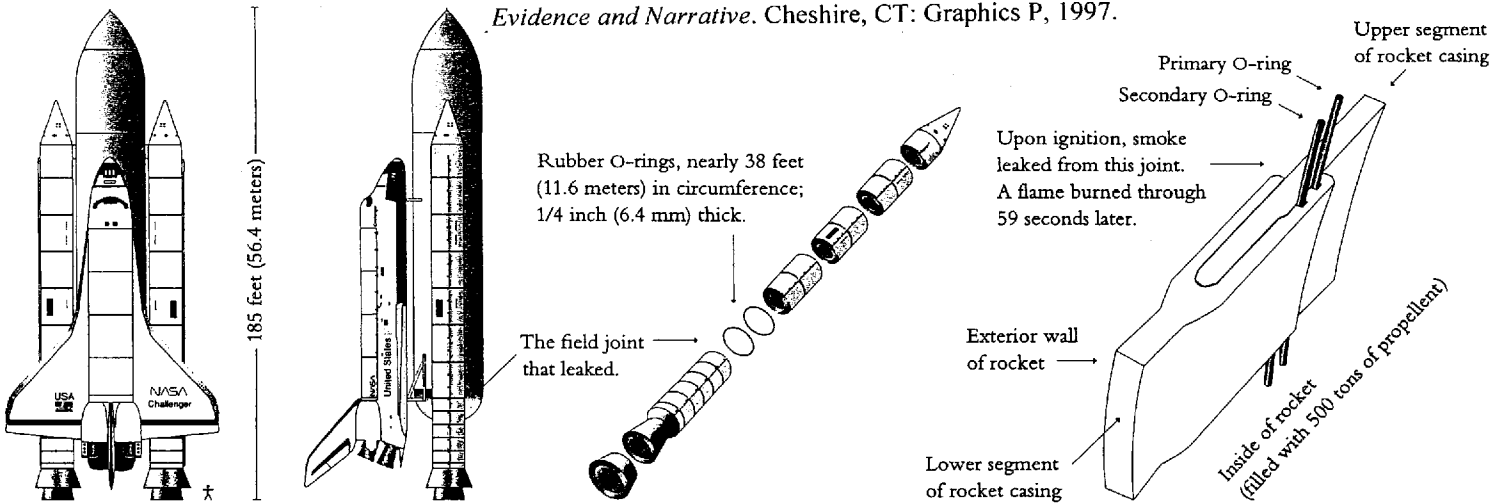
The shuttle consists of an *orbiter* (which carries the crew and has powerful engines in the back), a large liquid-fuel *tank* for the orbiter engines, and 2 solid-fuel *booster rockets* mounted on the sides of the central tank. Segments of the booster rockets are shipped to the launch site, where

they are assembled to make the solid-fuel rockets. Where these segments mate, each joint is sealed by two rubber O-rings as shown above. In the case of the Challenger accident, one of these joints leaked, and a torch-like flame burned through the side of the booster rocket.
